# Erosion and Sediment Control Regulation and Compliance in Victoria Ballarat 7 March 2006

# Clean Site

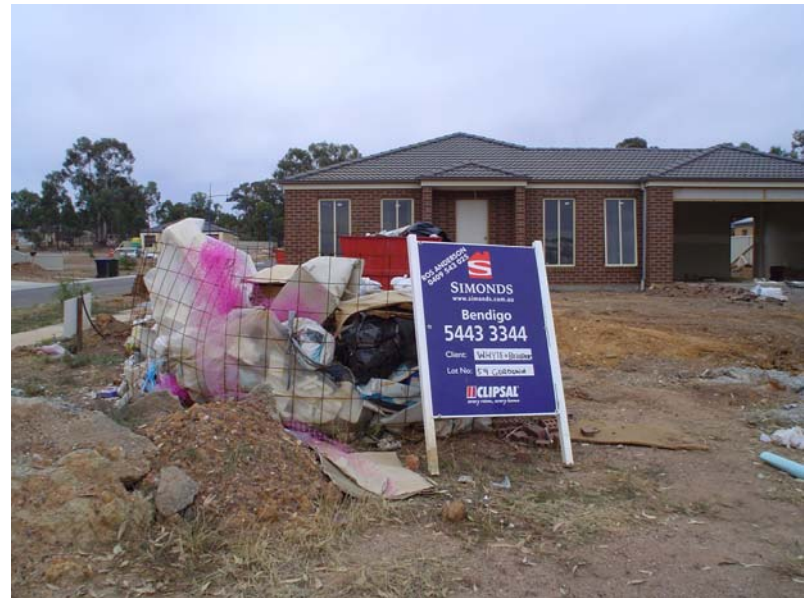
- 84% of sites had a waste receptacle, whilst only 52% of sites had a compliant waste bin
- Non-compliant bins were overflowing, had no closed lid or did not properly contain waste
- The average site had a moderate amount of windblown litter
- While most areas had local laws requiring waste to be contained in a closed waste receptacle, most sites did not comply.

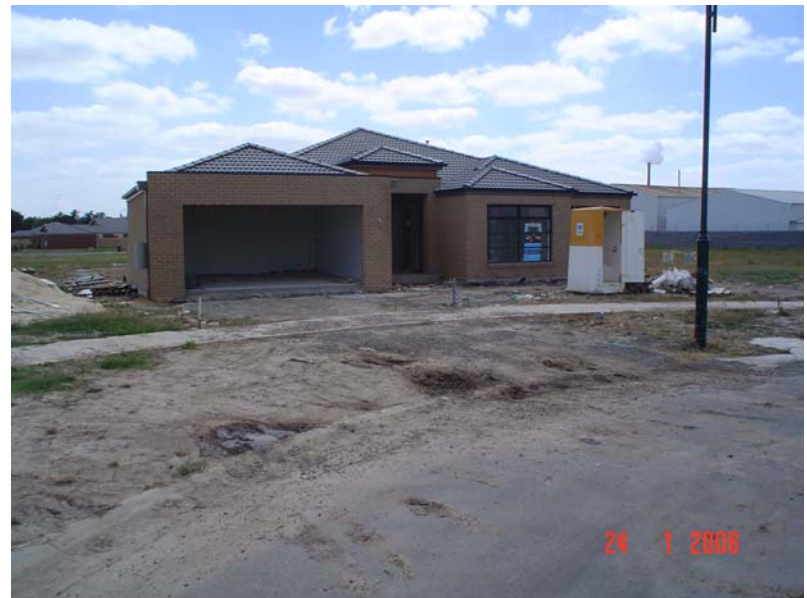
- The average stockpile was stored on site with runoff leading offsite
- The average site had a moderate amount of sediment movement
- 69% of sites had one or more sediment control measures (SCM)
- 52% of sites had a turf strip at the front of the site, with this being the most common SCM
- 92% of sites did not comply with local laws regarding sediment

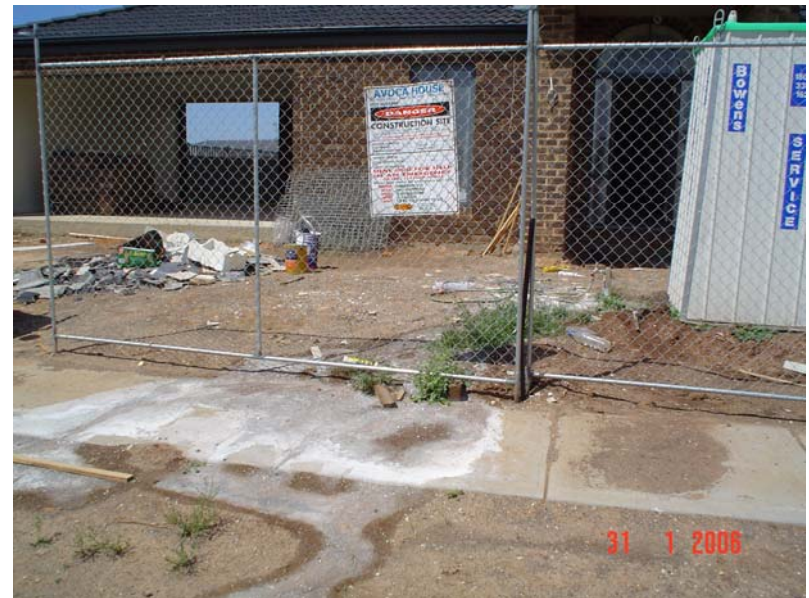
- An average of 56% of sites were accessed only via a proper crossing, with four out of the six regional areas having almost no sites using proper crossings
- 68% of sites showed evidence of vehicle tracked sediment
- Improper access to sites not only spreads sediment around, but damages gutters, footpaths and nature strips
- 21% of sites showed evidence of washings leaving the site
