Date:		
GMW	Apr-10	Stilling Pond (De-watering)	STP-01

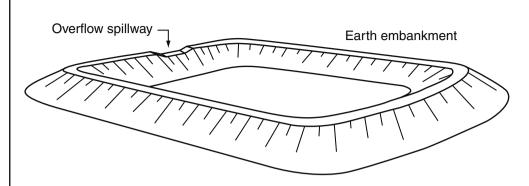
## (a) Stilling pond with overflow spillway

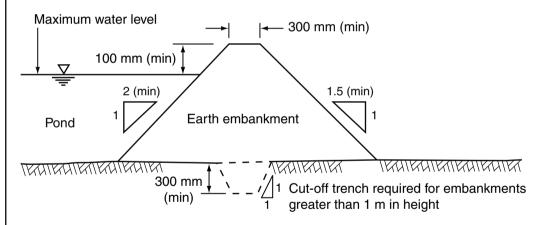
## (c) Typical cross-section of earth embankment

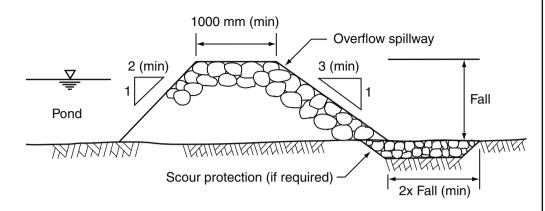
## (b) Typical cross-section of rock-lined overflow spillway
